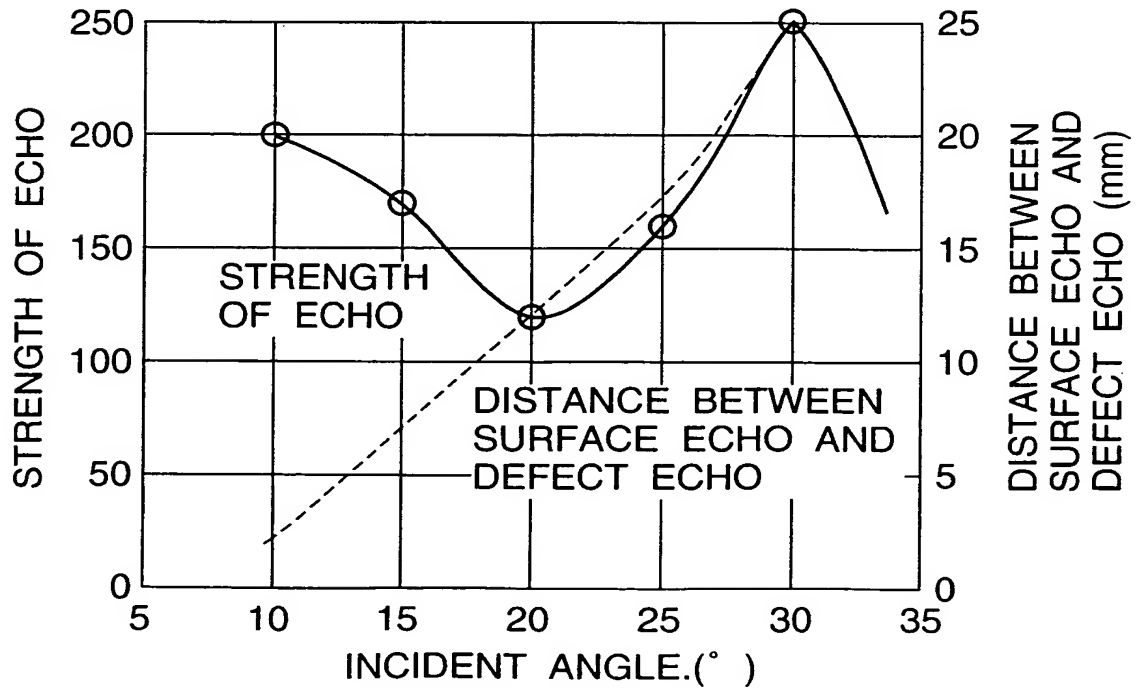
FIG.8

ULTRASONIC DETECTION RESULT NEAR SURFACE
PERPENDICULAR DETECT (WATER DISTANCE 20mm)

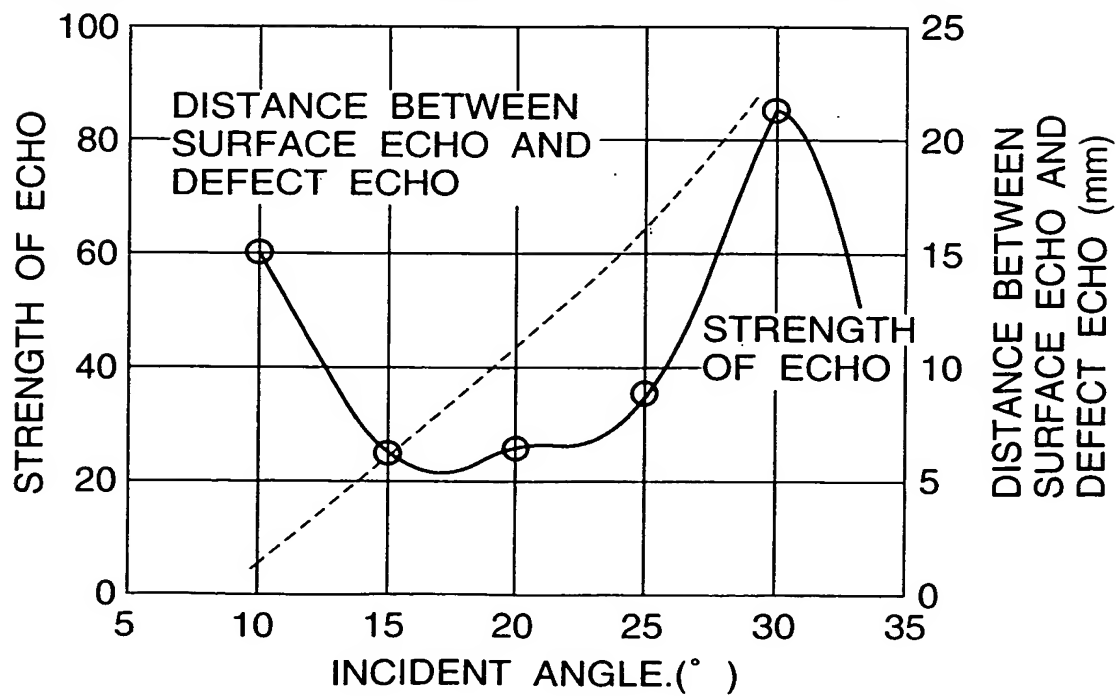
FIG.12

ULTRASONIC DETECTION RESULT NEAR SURFACE
PARALLEL DETECT (WATER DISTANCE 20mm)

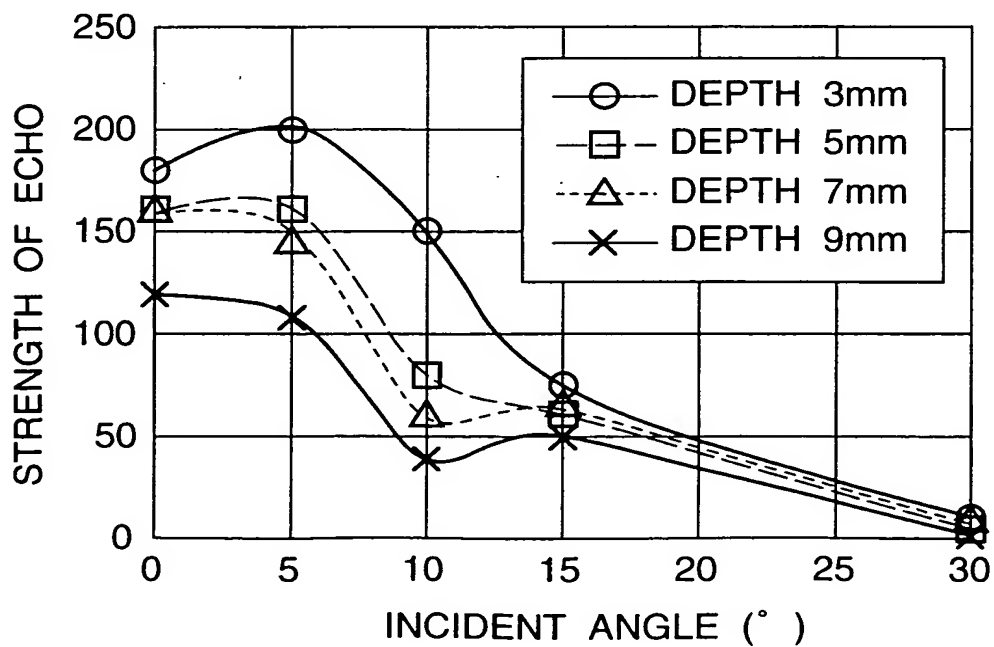
FIG.15

ULTRASONIC DETECTION RESULT WITHIN BEARING
INNER DETECT OF ϕ 0.5mm (WATER DISTANCE 15mm)
